IEEE Aerospace Conference 2019

# Regolith Particle Erosion of Material in Aerospace Environments

Emma Bradford, Jason Rabinovitch, and Mohamed Abid  
March 4, 2019

**Jet Propulsion Laboratory**  
California Institute of Technology

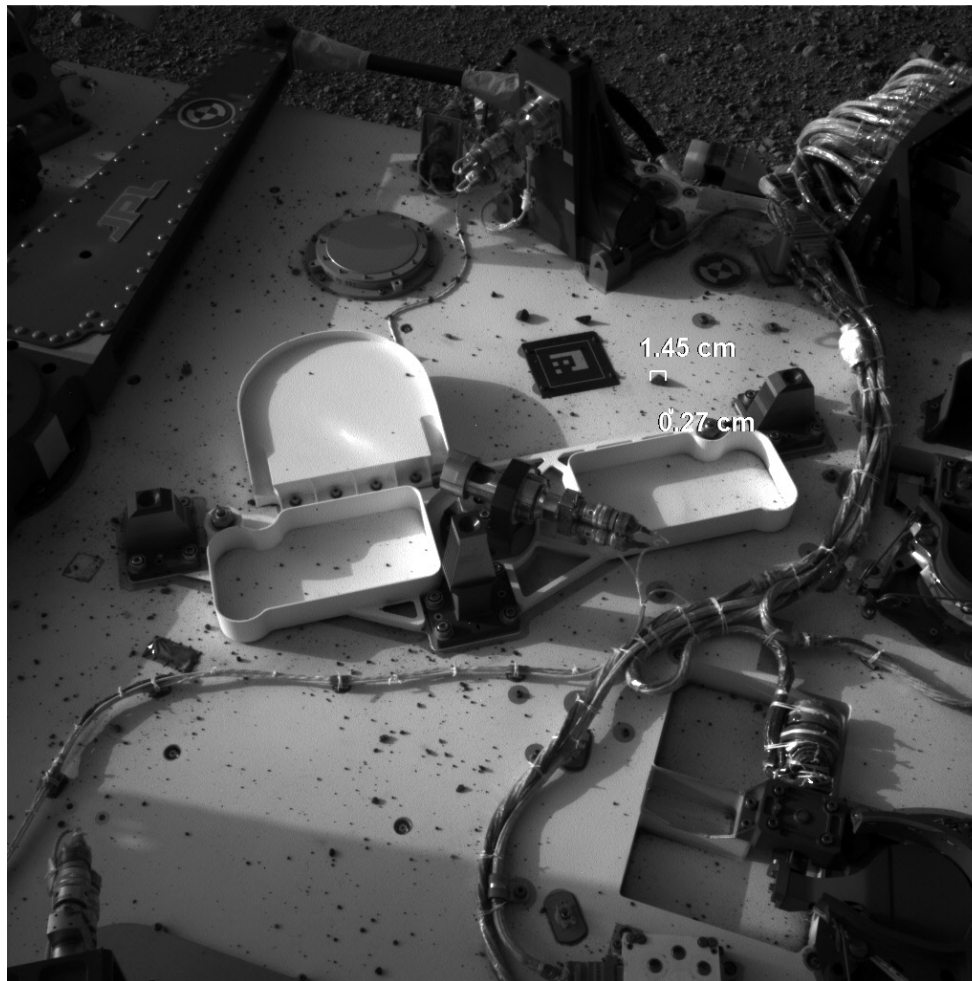
Mars Science Laboratory (MSL) immediately after landing (left) and throughout the mission life (right).

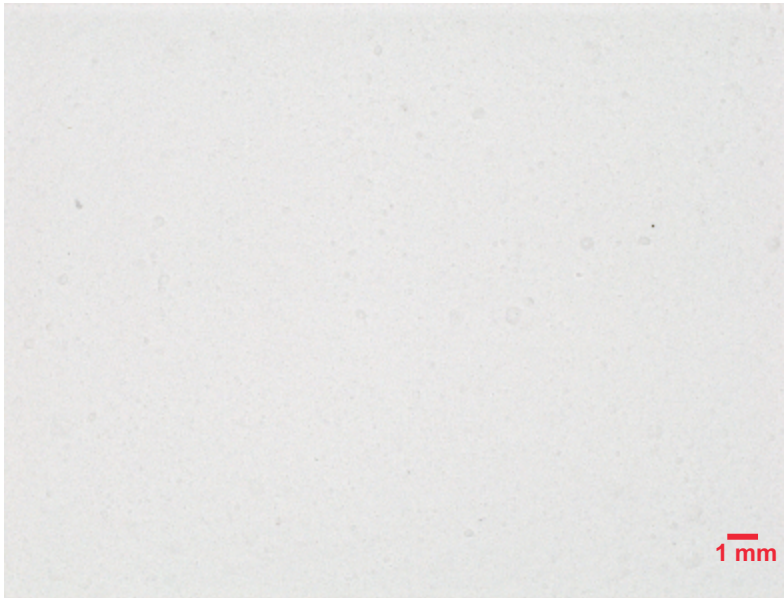
Paint before exposure.

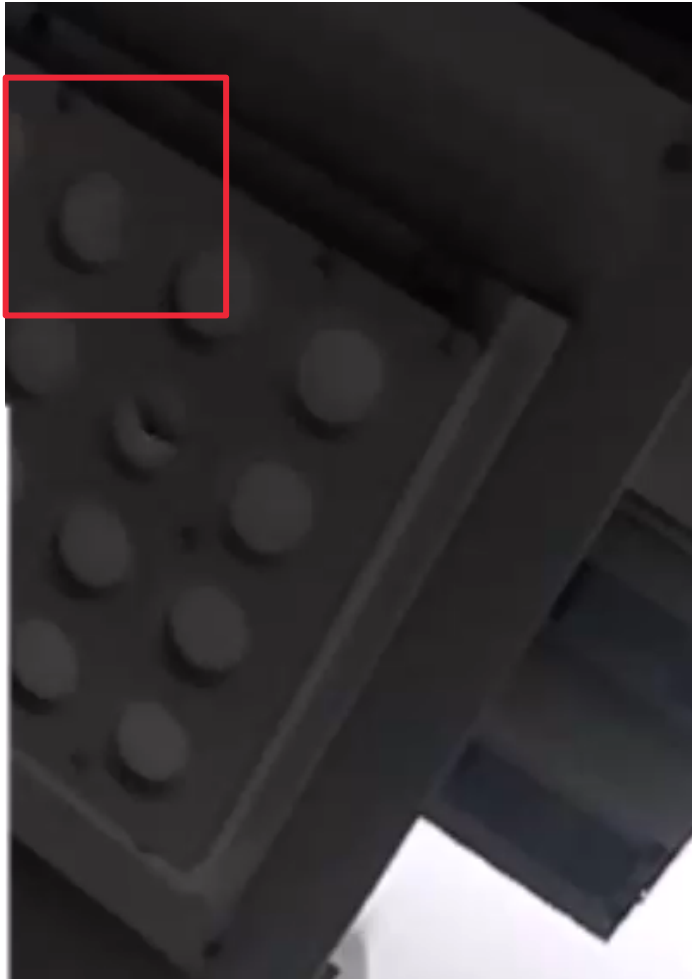
S13 paint coupon exposed to 177-250 micron particles at 160 m/s after 5 g/cm<sup>2</sup>.

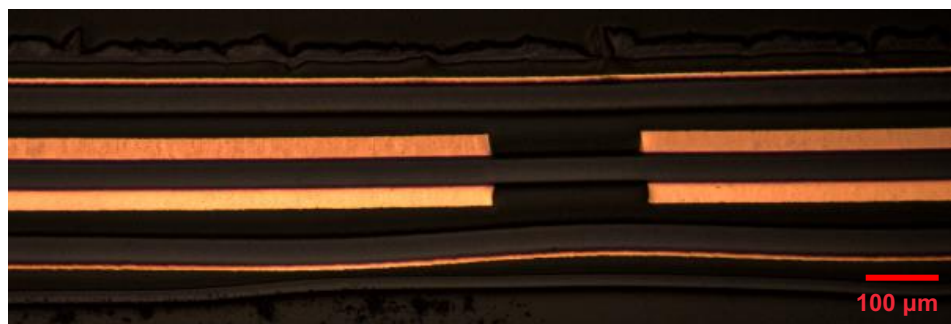
Gravel and Rock

Image and cross-section shows only erosion of the Kapton outer layer.

Worst Case: Cross-section shows no evidence of shorts or opens

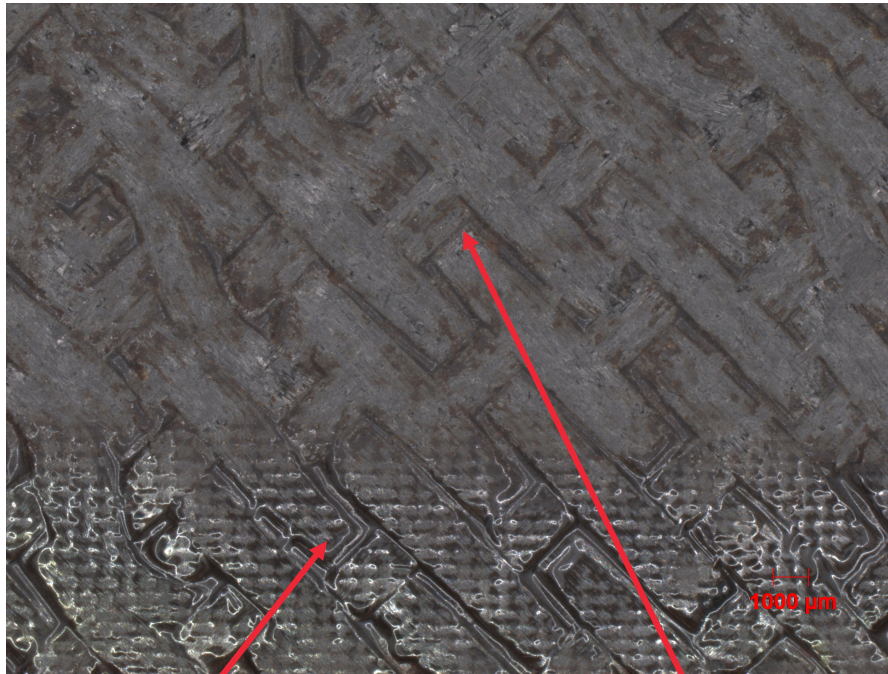
Not Eroded

Eroded

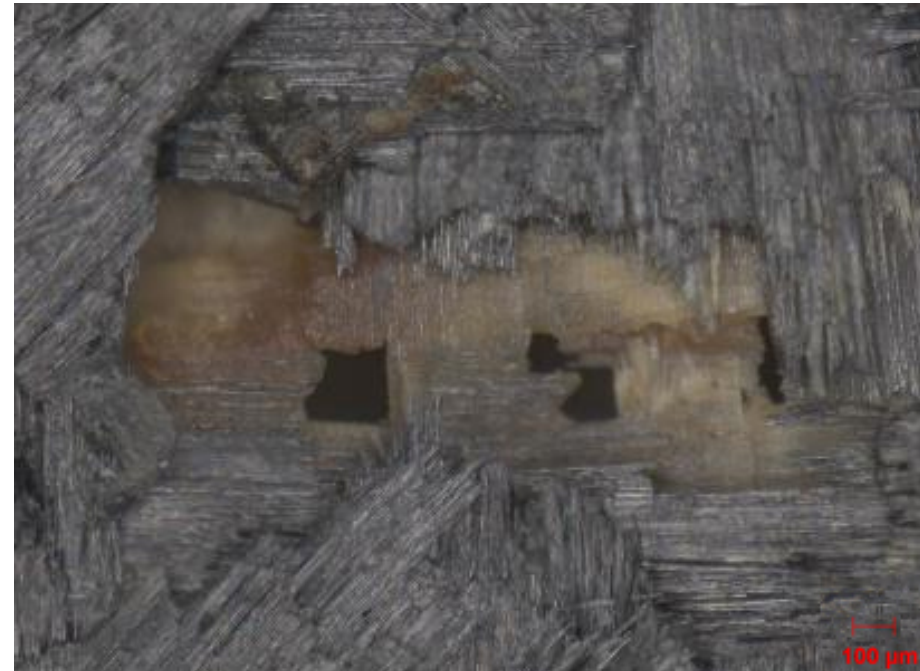
Worst Case: Broken fibers and microscopic through holes.

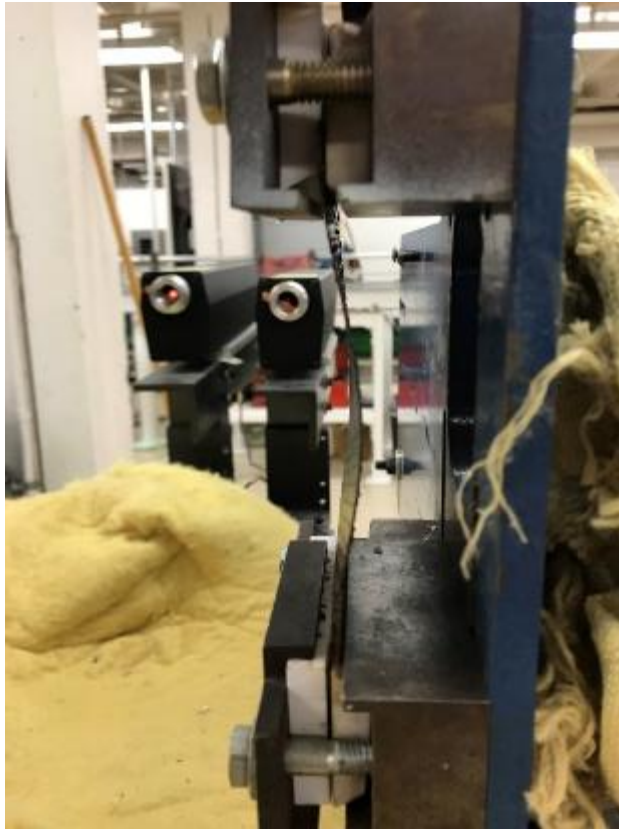
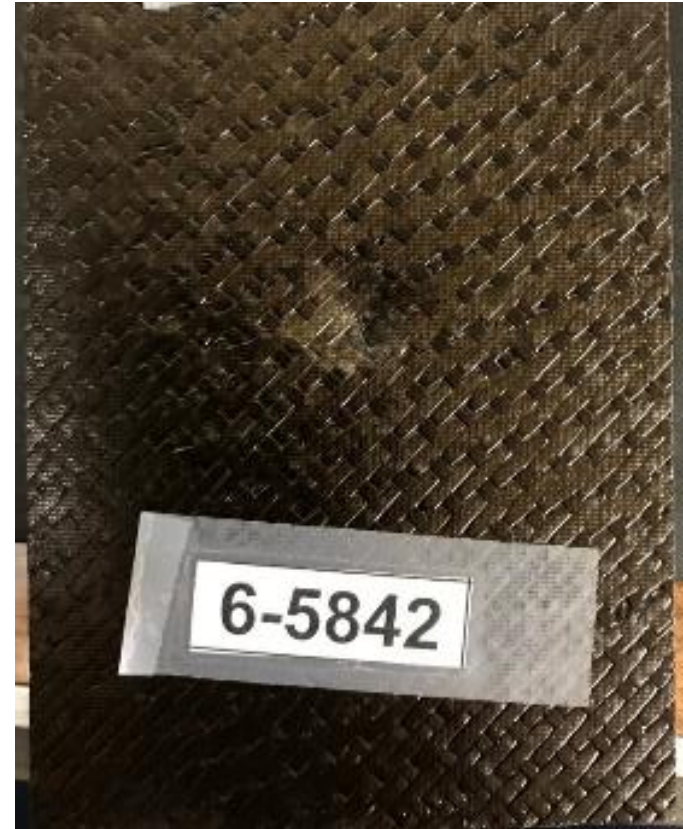
Static deformation of about 8 mm after impact from one 15.8 mm particle traveling at 25 m/s

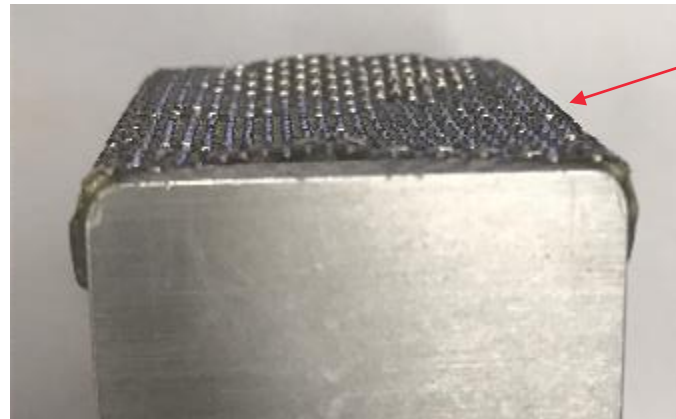
Screen deformed  
from particles  
larger than 2 mm.

No evidence of damage from particles  $< 2$  mm.

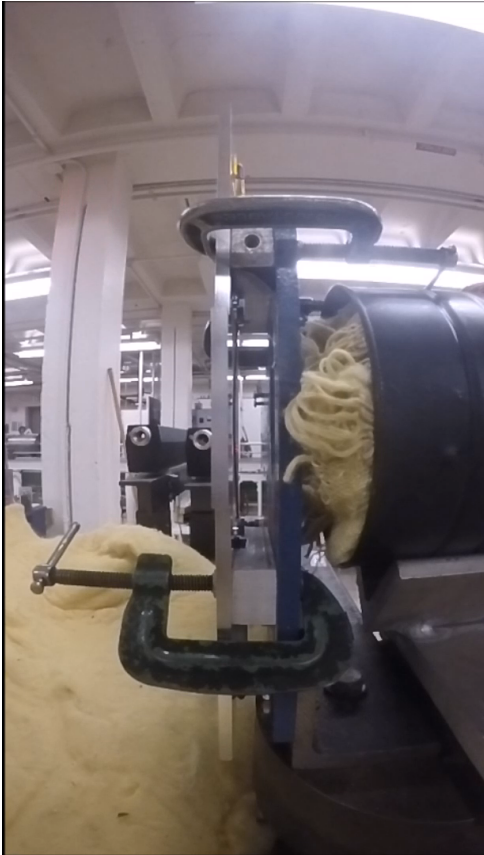
Deformed <1.15"

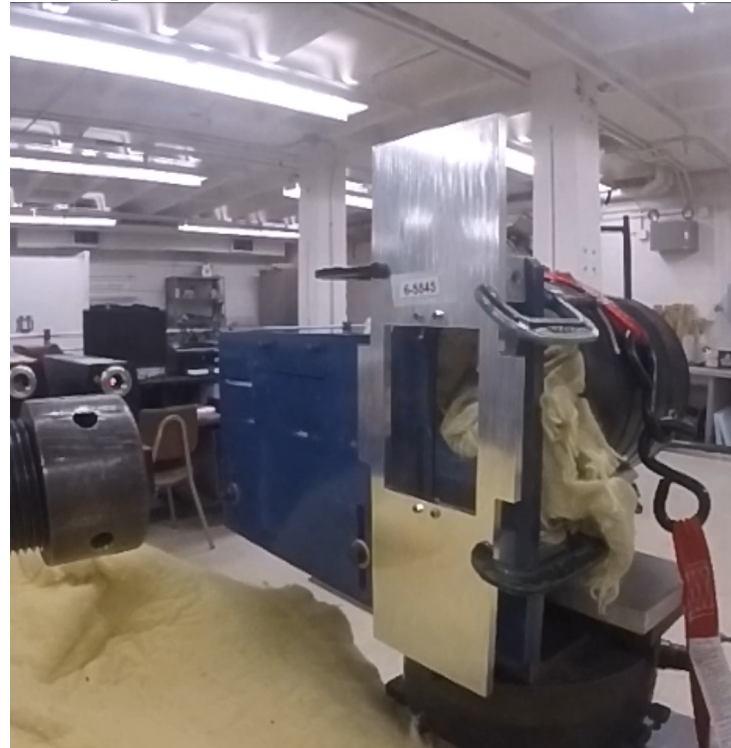
Deformed ~2"

- Fiber Optic Cable deformed about 2" after impact from a 15.8 mm particle traveling at 20 m/s
- Maximum deformation according to manufacture is 2"
- Preliminary attenuation measurement show light dimmer than pre-test
- Post-Test attenuation measurement all pass but one

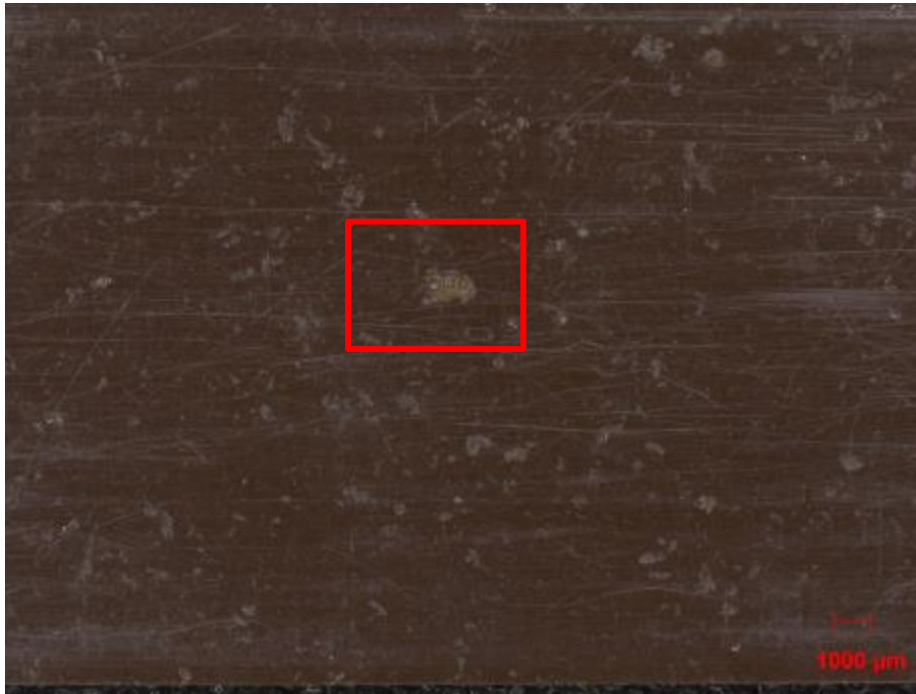
Metal trace is  
not exposed

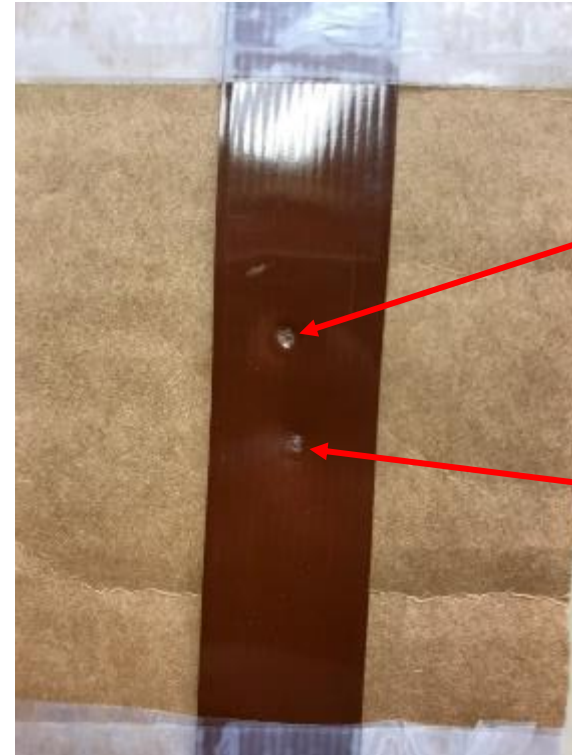
Impact with Al  
behind Flex  
Cable

Impact with  
cardboard  
behind the  
Flex Cable

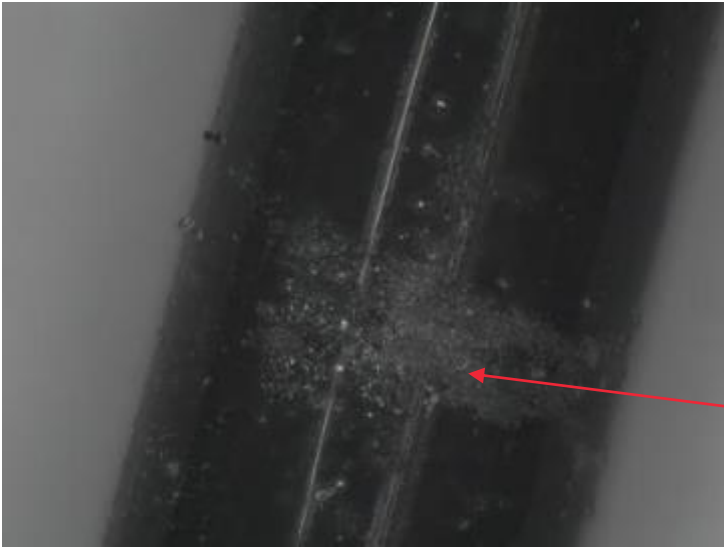
Particles imbedded in the FOC jacket and scratches

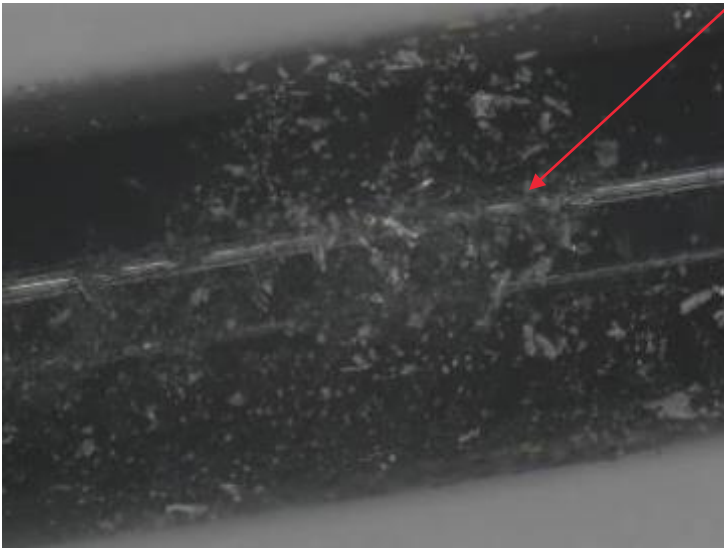
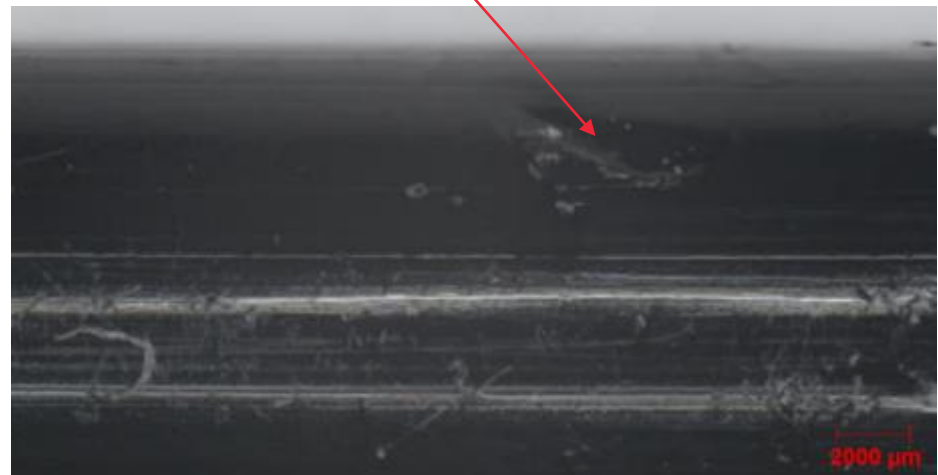
Indentation in the FOC jacket
